REPORT ON TEMPERATURE MEASUREMENT ON THE BACK PAINT GLASS WITH TEMPERED

Client : DSA Co., Ltd.
Project : Testing of Back Paint Glass with Tempered
Sample Description : Back Paint Glass with Tempered
Nominal thickness : 6 mm

METHOD STATEMENT FOR TEMPERATURE MEASUREMENT ON BACK PAINT GLASS WITH TEMPERED

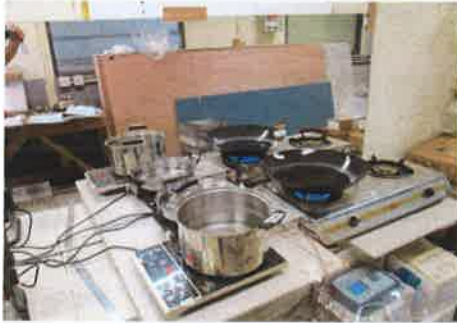
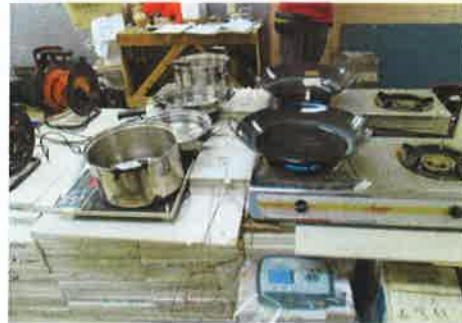
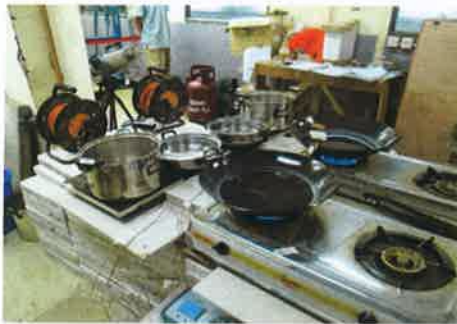
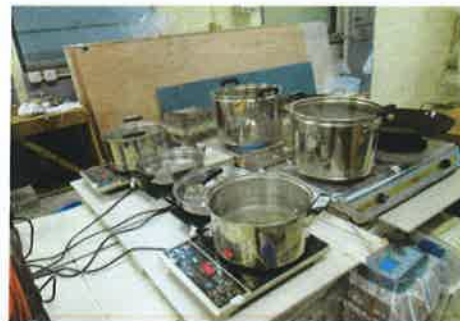
Test Configuration
Sample I.D.: ST150758/1

Remarks : 1.) The test results relate only to the samples tested.
2.) The test configuration and sample after test are shown in the photographs on page 4 of this report.

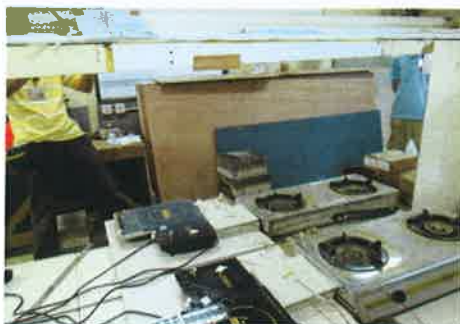
Sample After Test
Sample I.D.: ST150758/1
