Report No. : 151425EN150650(1)A

## Test Report on Analysis of Mirror

Client : DSA Company Limited  
Client's address : Room 03, 19/F, New Commerce Centre,  
19 On Sun Street, Shatin NT, HK  
Project : -  
Sample description : One sample of 6mm Thick Mirror  
Sample identification : -  
Test required : Neutral Salt Spray Test for 24 hours

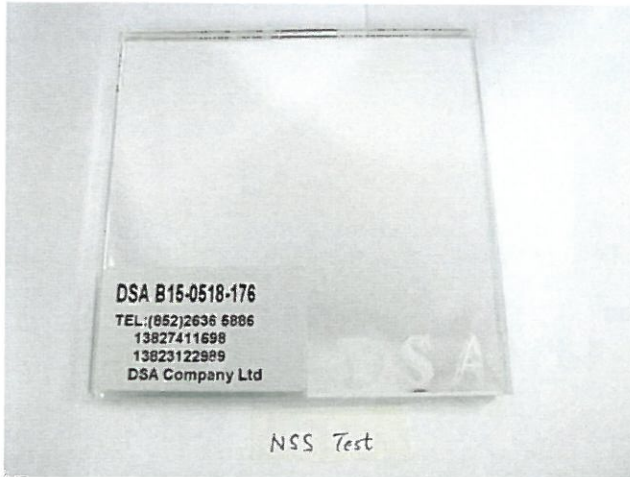
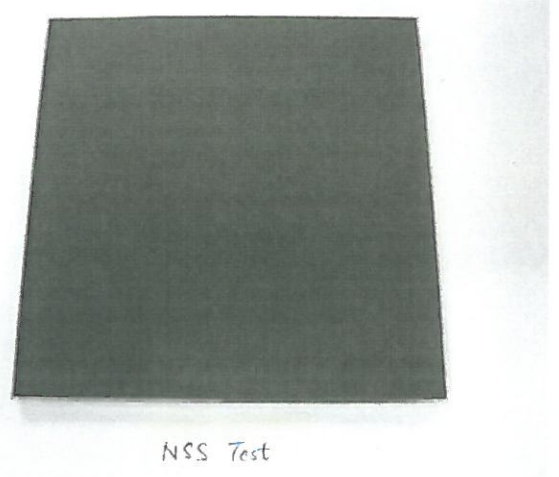
Photos of test specimen before neutral salt spray test.

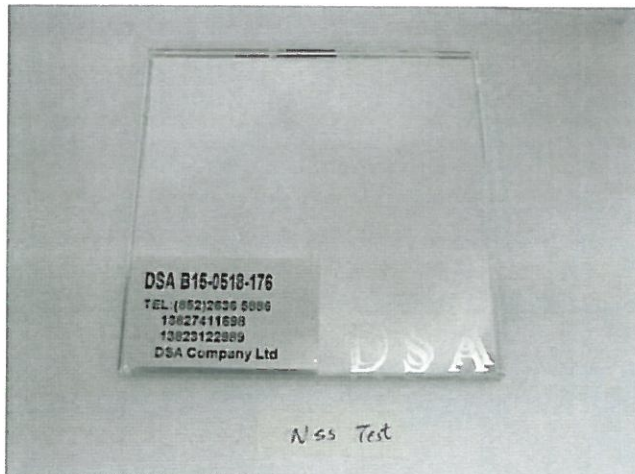
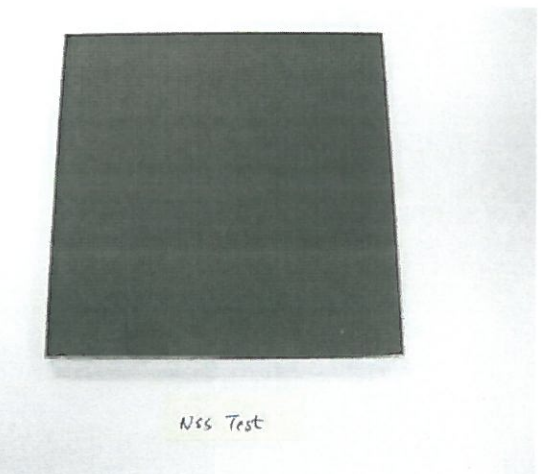
Lab Sample ID	Result
EN150650/1	No discernible change

Photos of test specimen after neutral salt spray test for 24 hours.
